U.S.S. TEXAS (BB-35)

OPTION 6 TANK INSPECTION AND REPAIR ASSESSMENT

Vessel Survey Report No. 2461

Purpose of survey: Option 6 Tank Inspection & Repair Assessment

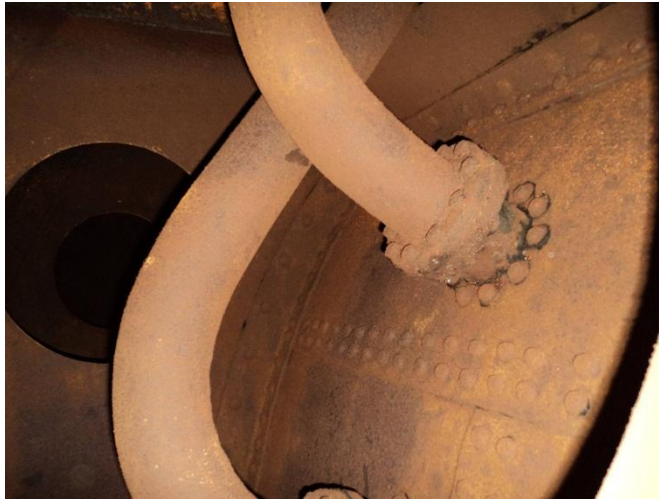
Figure 10. Through-hull piping in lower flat of B-72F to blister tankage.

Verify that blister tankage outboard is dry, remove piping and weld two 12" x 12" $\frac{3}{4}$ " A-36 mild steel doubler plate over holes in side shell.

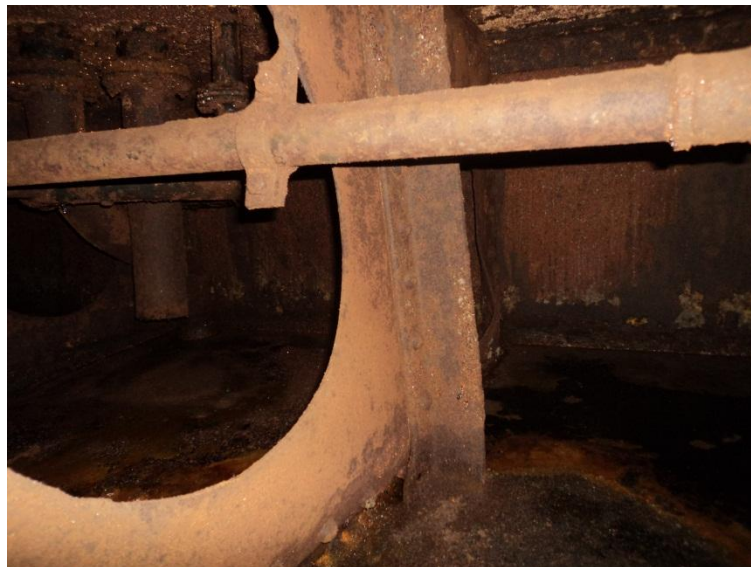
Figure 19. Standing oil/water in tank bottom B-82F.

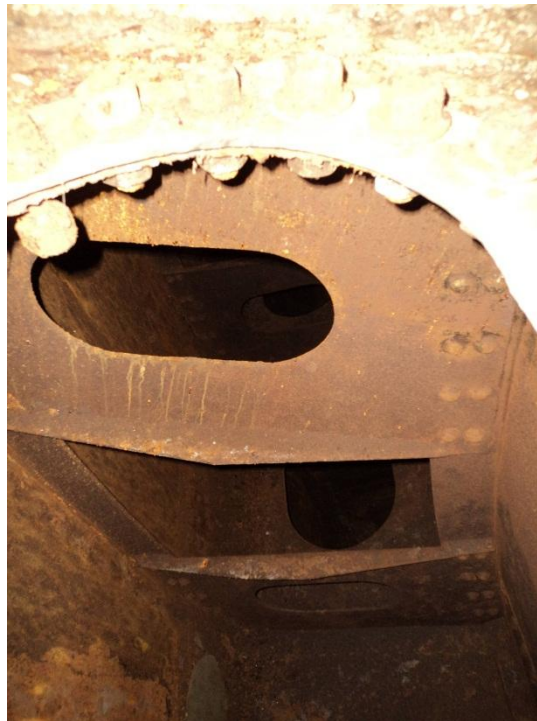
Figure 33. Lower flats of D-32F.

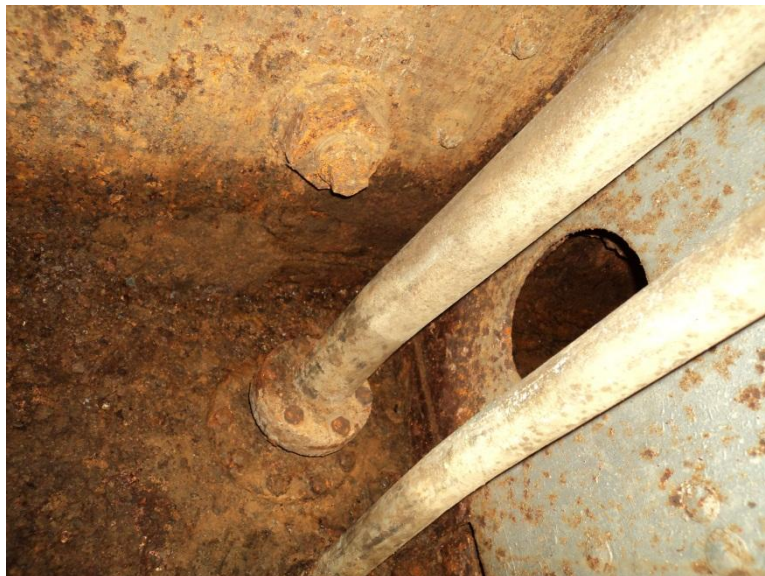
Figure 37. Wasted plating below armor hanging bolt in D-91F.

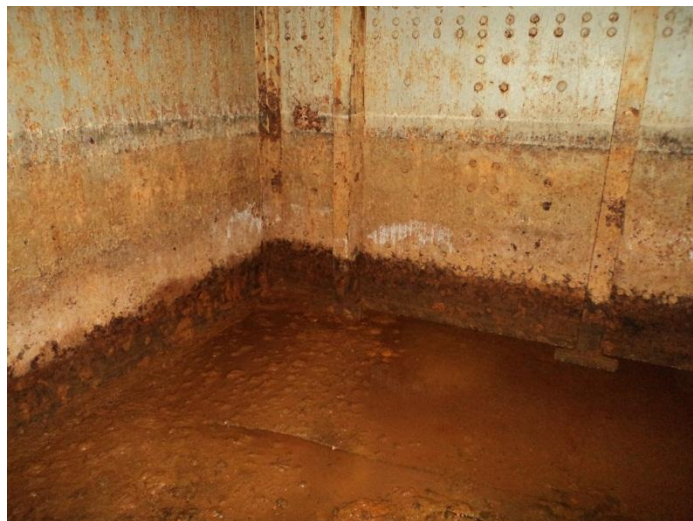
Figure 39. Wasted shell plating within D-41P.

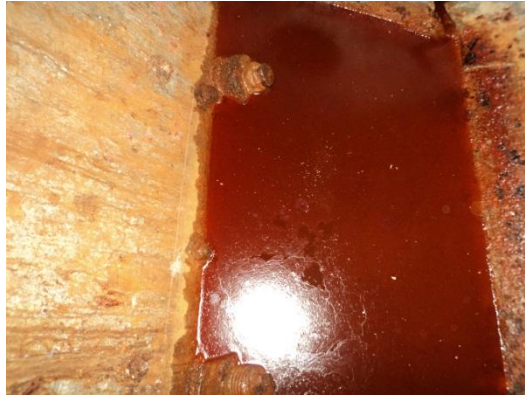
Tank flooded; not inspected at time of survey.

Figure 40. Detail of flooded D-90V.

Ensure adjacent blister tankage is dry. Properly prepare shell plating and install estimated 400 square feet of $\frac{3}{4}$ " A-36 mild steel doubler plating.

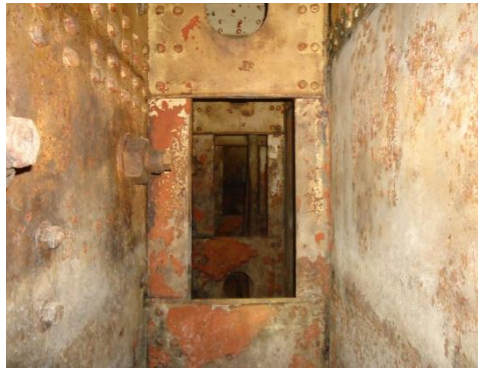
Space is mildly corroded with partially intact paint system on the upper tank and mild/moderate corrosion (25 – 35%) of shell plating and scantlings as one proceeds to tank bottom. Moldy throughout space. Minor seepage of oil from riveted seams in corners. No standing water. This space requires no structural repairs or modifications.

Figure 54. Interior of B-27S, looking aft.

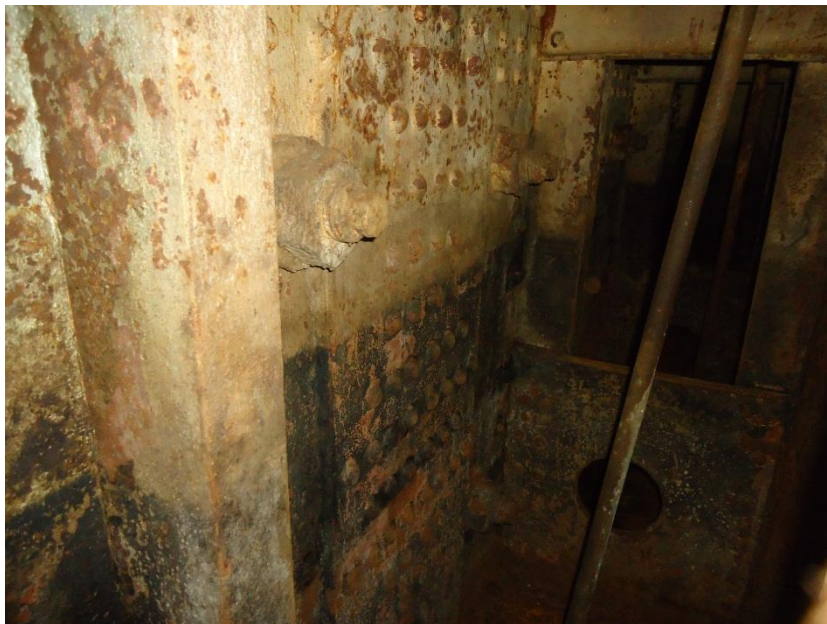
Space is mildly corroded with partially intact paint system on the upper tank and mild/moderate corrosion (15 – 20%) of shell plating and scantlings as one proceeds to tank bottom. No standing water. This space requires no structural repairs or modifications.

Figure 57. Interior of B-28S.

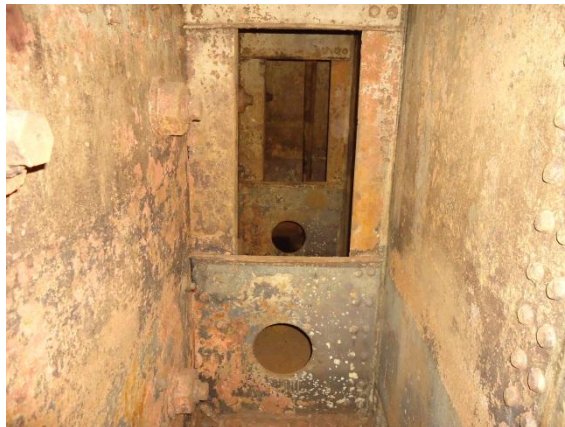
Space is mildly corroded with partially intact paint system on the upper tank and mild/moderate corrosion (15 – 20%) of shell plating and scantlings as one proceeds to tank bottom. No standing water. This space requires no structural repairs or modifications.

Figure 59. Interior of B-29S.

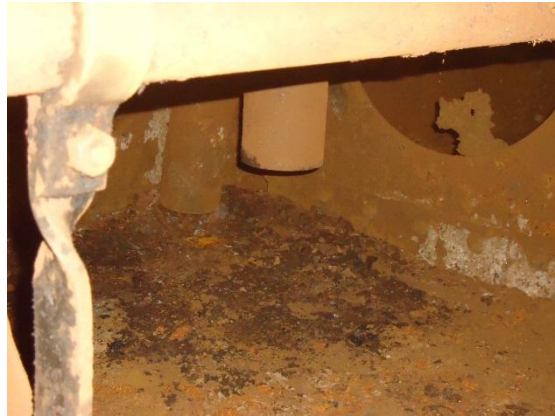
Space is moderately corroded, but not structurally deficient. Upper tank side shell and scantling degraded 25%, floors 20 -30%. Minor seepage of oil emanating from riveted seams in upper flat. Intermediate flat exterior shell plating slightly buckled throughout space but is not considered a structural issue. Lower tank side shell and scantlings degraded 30 – 40%, floors degraded 40%. Rivets degraded 20 – 25%. Peeling paint and much rust/scale abound. Minor seepage of oil from riveted seams in corners. 2 - 3” of standing oily muck/rust in bottoms.

Figure 60. Bottom of tank in B-81F.

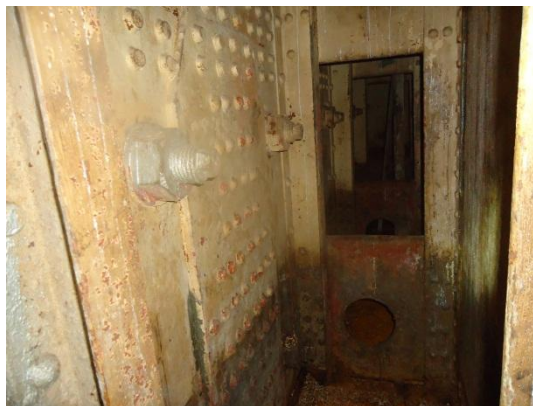
Space is mildly corroded with partially intact paint system on the upper tank and mild/moderate corrosion (15 – 20%) of shell plating and scantlings as one proceeds to tank bottom. No standing water. This space requires no structural repairs or modifications.

Figure 61. Interior of B-31S.

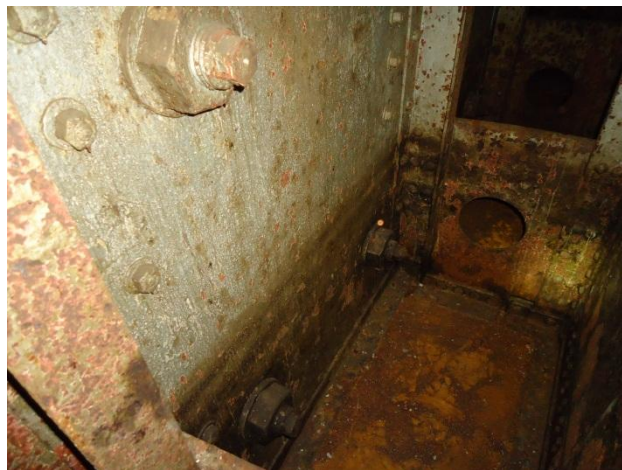
Space is mildly corroded with partially intact paint system on the upper tank and mild/moderate corrosion (15 – 20%) of shell plating and scantlings as one proceeds to tank bottom. Minor oil seepage from riveted seams. No standing water. This space requires no structural repairs or modifications.

Figure 63. Interior of C-44S.

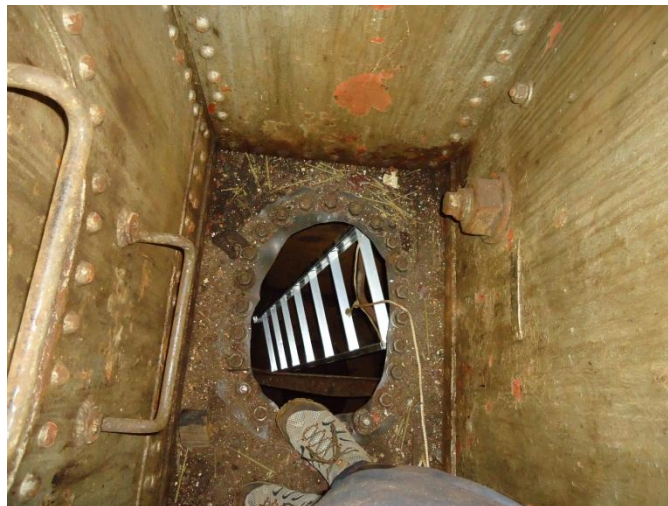
Space is mildly corroded with partially intact paint system on the upper tank and mild/moderate corrosion (15 – 20%) of shell plating and scantlings as one proceeds to tank bottom. No standing water. This space requires no structural repairs or modifications.

Figure 65. Looking at floor on C-45S.

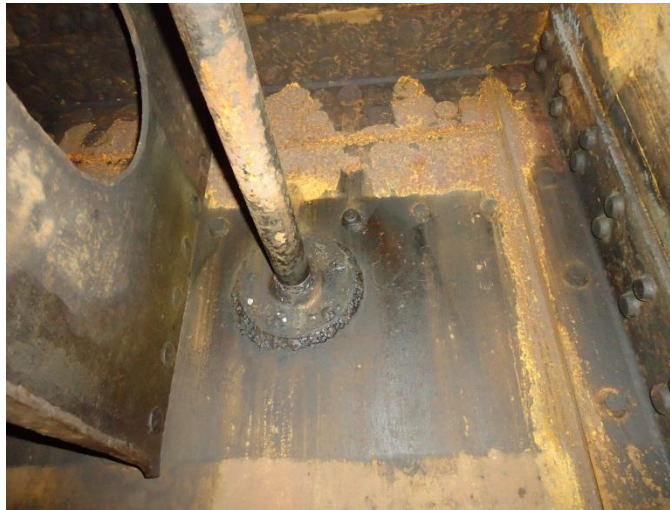
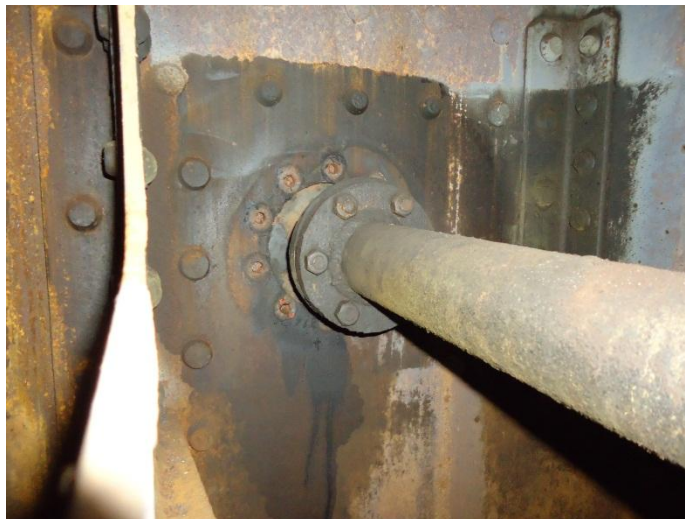
Figure 66. Through-hull piping into blister tank in C-83F.

Figure 67. Through-hull piping into blister tank in C-83F.

Ensure dewatered blister tankage outboard, cut away two (2) 3" piping and install 12" x 12" $\frac{3}{4}$ " A-36 mild steel doubler plate over each pipe cut-out on upper flat.

Ensure dewatered blister tankage outboard, cut away one (1) 6" piping and install 12" x 12" $\frac{3}{4}$ " A-36 mild steel doubler plate over each pipe cut-out on lower flat.

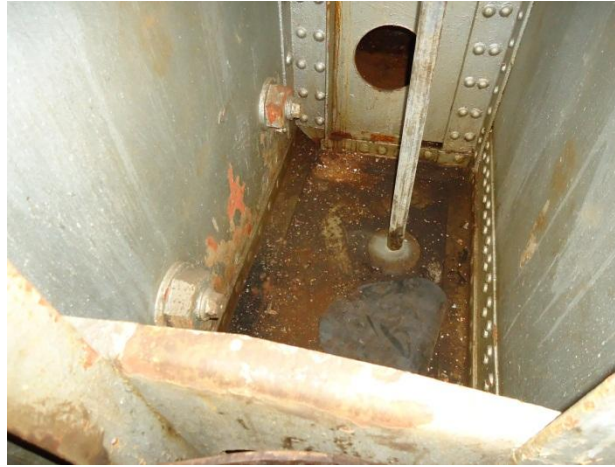
Space is mildly corroded with partially intact paint system on the upper tank and mild/moderate corrosion (15 – 20%) of shell plating and scantlings as one proceeds to tank bottom. No standing water. This space requires no structural repairs or modifications.

Figure 68. Interior of tank C-46S.

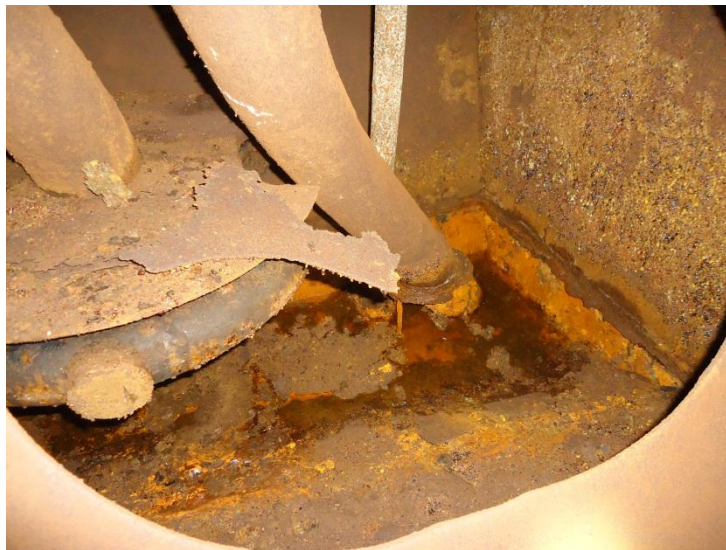
Space is mild/moderately corroded, but not structurally deficient. Upper tank side shell and scantling degraded 10%, floors 20 -30%. Intermediate flat showing 15 – 20% wastage throughout. Lower tank side shell and scantlings degraded 20%, floors degraded 30%. Rivets degraded 20 – 25%. Peeling paint and much rust/scale abound. Minor seepage of oil from riveted seams in corners on intermediate and bottom flats. 1 - 3" of standing water and rust in bottoms

Figure 69. Bottom of tank in C-85F.

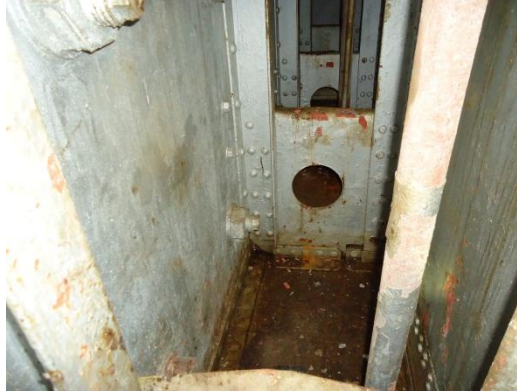
Space is mildly corroded with partially intact paint system on the upper tank and mild/moderate corrosion (15 – 20%) of shell plating and scantlings as one proceeds to tank bottom. No standing water. This space requires no structural repairs or modifications.

Figure 70. Interior of C-47S.

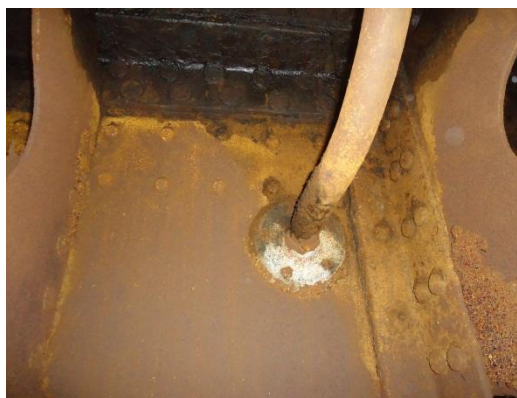
Figure 71. 2" pipe into blister tank from C-87F

Ensure dewatered blister tankage outboard, cut away two (2) 3" piping and install 12" x 12" $\frac{3}{4}$ " A-36 mild steel doubler plate over each pipe cut-out on upper flat.

Ensure dewatered blister tankage outboard, cut away one (1) 6" piping and install 12" x 12" $\frac{3}{4}$ " A-36 mild steel doubler plate over each pipe cut-out on lower flat.

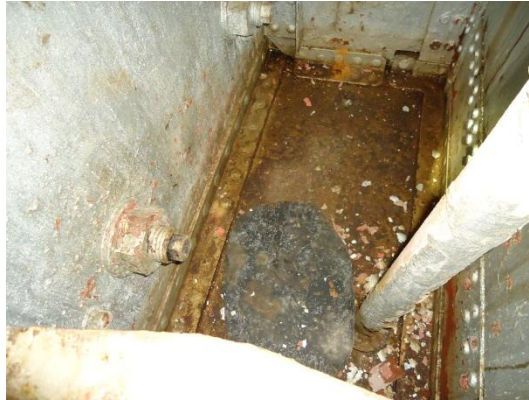
Space is mildly corroded with partially intact paint system on the upper tank and mild/moderate corrosion (15 – 20%) of shell plating and scantlings as one proceeds to tank bottom. No standing water. This space requires no structural repairs or modifications.

Figure 72. Interior of C-48S.

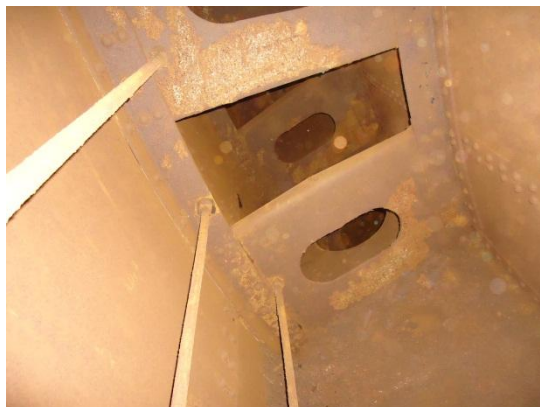
Figure 73. Interior of tank C-89F.

Ensure dewatered blister tankage outboard, cut away two (2) 6" piping and install 14" x 14" $\frac{3}{4}$ " A-36 mild steel doubler plate over each pipe cut-out on lower flat.

Ensure dewatered blister tankage outboard, cut away one (1) 8" piping and install 16" x 16" $\frac{3}{4}$ " A-36 mild steel doubler plate over each pipe cut-out on lower flat.

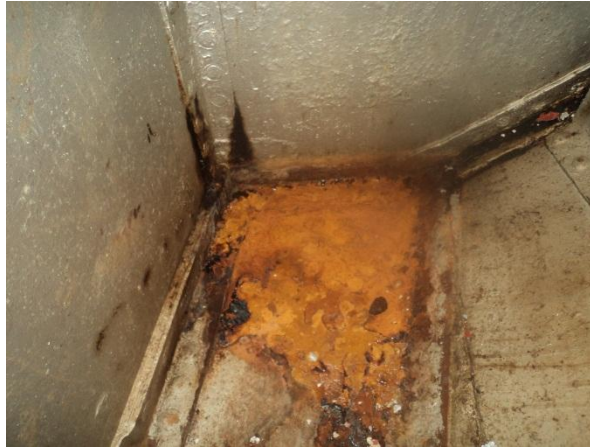
Space is mildly corroded with partially intact paint system on the upper tank and mild/moderate corrosion (15 – 20%) of shell plating and scantlings as one proceeds to tank bottom. No standing water. This space requires no structural repairs or modifications. **Upper ladder rung broken.**

Figure 74. Lower forward portion of D-39S.

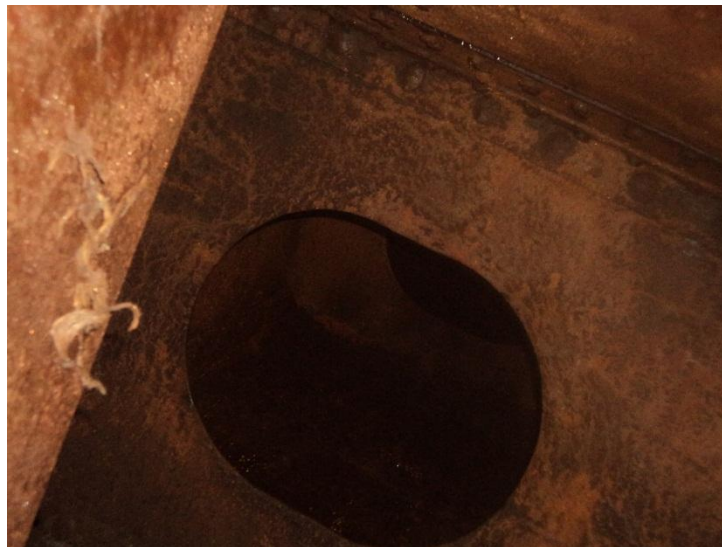
Space is mild/moderately corroded, but not structurally deficient. Upper tank side shell and scantling degraded 5 - 10%, floors 30 -40% degradation in lower flat. Rivets degraded 10 – 15%. Peeling paint and some rust/scale in bilges.. Much seepage of oil from riveted seams in corners on intermediate and bottom flats. 1 - 3” of standing water and rust in bottoms. Recent flooding noted, patched shell plating.

Figure 77. Turn of bilge frames and shell plating in D-93F.
